**Site Reconnaissance and
Conceptual Design for Dam
Removal – Indian Head Dam**

Hanover and Hanson, Massachusetts

June 30, 2021

Revised March 29, 2022

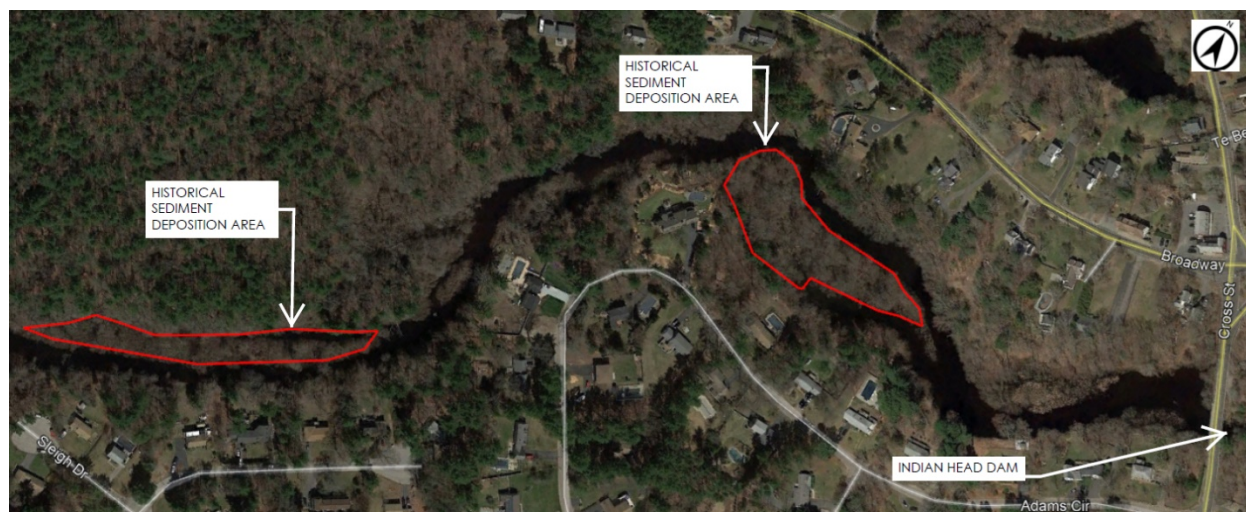
Figure 1. Approximate areas of potential historical sediment deposition areas in the Indian Head Dam impoundment

There was some variation in probed sediment depth measurements. The greatest depths of probed sediment were 2.3 ft and 2.0 ft, located within the middle of the impoundment in the Northeast Impoundment Zone approximately 170 ft upstream from the dam spillway and on the side of the impoundment next to a vegetated wetland area approximately 2,200 ft upstream of the dam spillway, respectively. In general, the average probed sediment depth was 1.2 ft in the Northeast Impoundment Zone. The probed sediment depths were less in the Southwest Impoundment Zone with an average of 0.8 ft and there were more occurrences of firm refusals to gravel and sand compared to the Northeast Impoundment Zone.

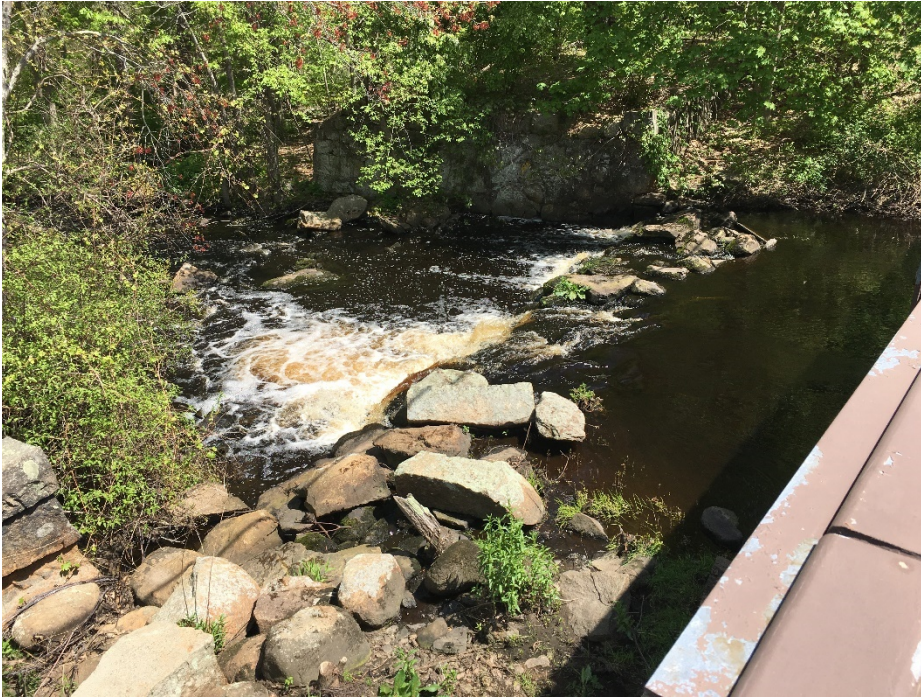
Photo 1. Overview of Indian Head Dam spillway

Following installation of scour countermeasures, a gradual removal of the large granite blocks and boulders that comprise the dam spillway would begin the dam removal process. Since the remaining granite and boulder remnants of the former spillway at Indian Head Dam compose the primary stream barrier and dam at this site, removal of these materials would substantially result in free-flowing conditions at this site. There may be an opportunity to reuse the granite blocks and boulders from the dam spillway as part of the design of rock riffles at this site, if these features are incorporated into the dam removal design.

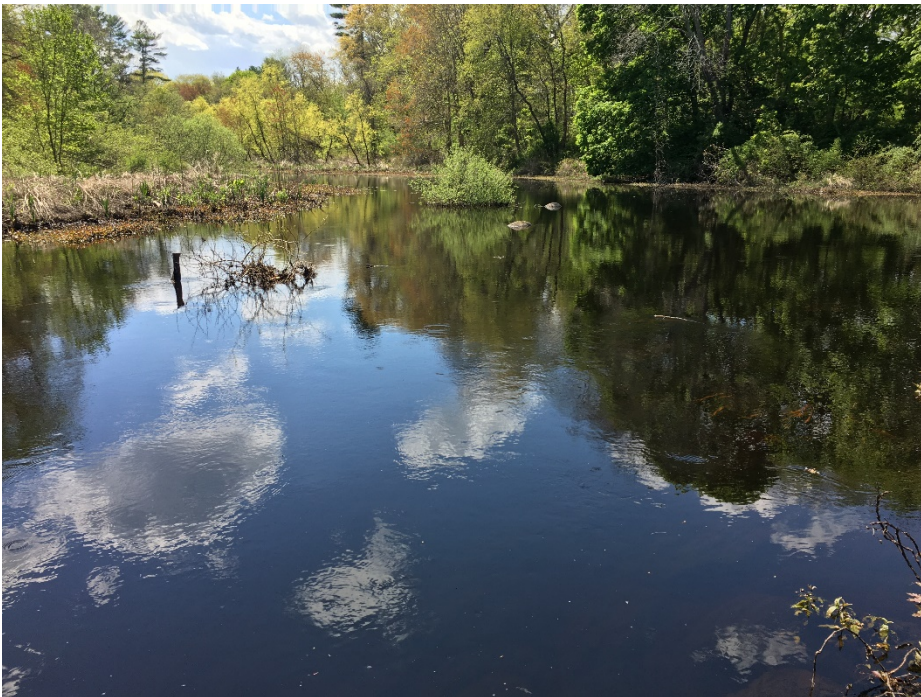
Photo 2. Overview of Indian Head Dam impoundment facing upstream

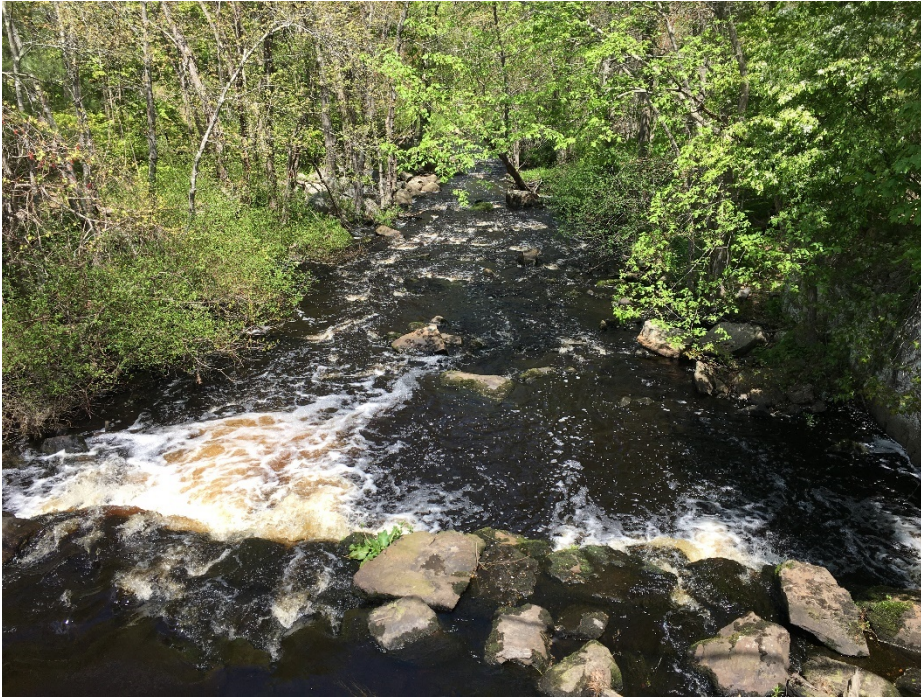
Photo 3. Overview of Indian Head River facing downstream from the Indian Head Dam spillway

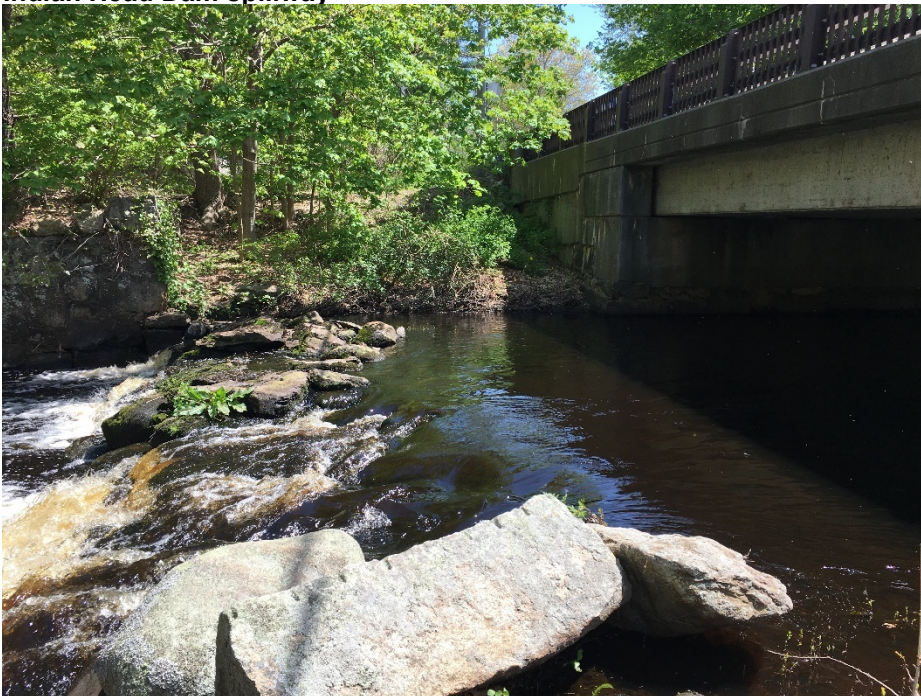
Photo 4. Overview of right spillway abutment

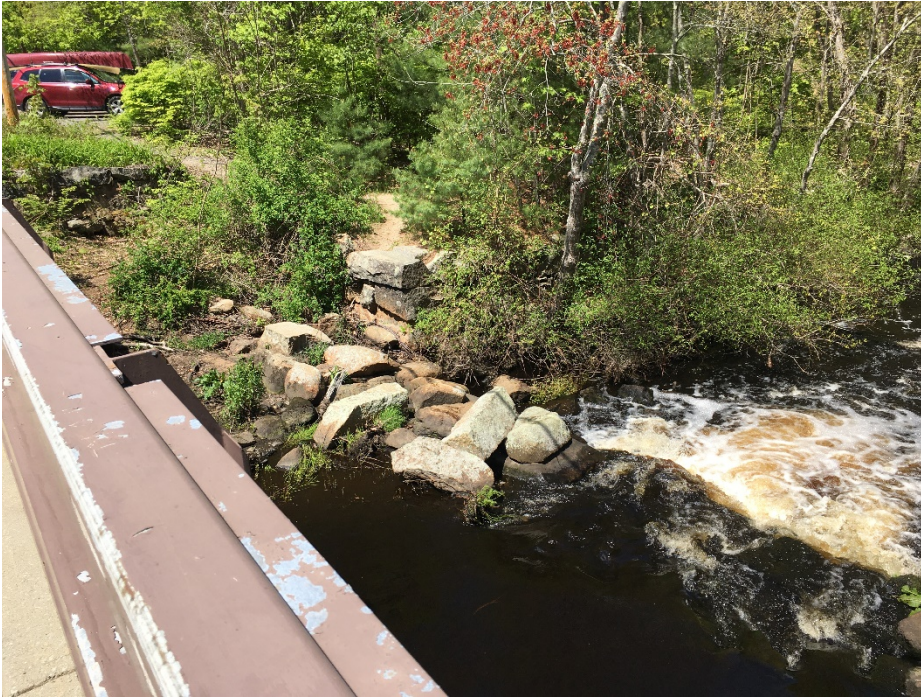
Photo 5. Overview of left spillway abutment

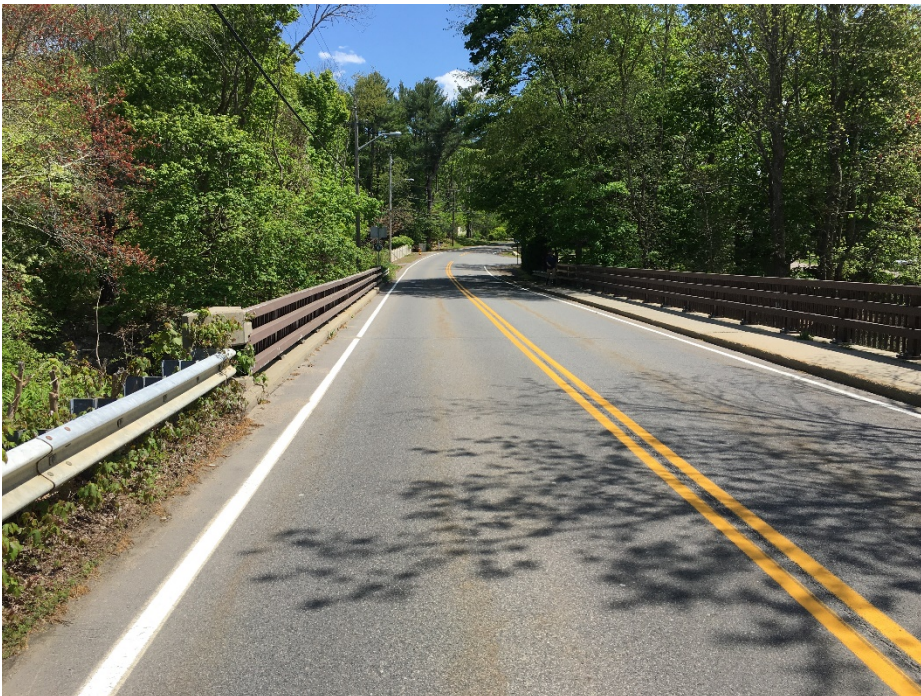
State Street Bridge (Bridge No. H-07-004) is located approximately 20 ft upstream of Indian Head Dam. The bridge appears to have been rehabilitated in 1995 based on the information presented in the State Street Bridge Drawings. The rehabilitation appears to have included replacement of the bridge superstructure. The clear span opening of the bridge is 49 ft and the low chord of the bridge is approximately 5 ft above the normal water surface. There is no information in the State Street Bridge Drawings that indicate the depth of the bottom of the abutment footings aside from a detail that estimates concrete to be poured to an elevation of approximately 30.5 ft (NGVD29) with actual elevations determined in the field during excavation. The existing stone abutment was to remain as indicated in the drawings. Based on this information, the abutments may be approximately 3 ft below the Indian Head Dam spillway weir. Therefore, removal of Indian Head Dam should include considerations for protection of the abutments, including the potential need for scour countermeasures.

Photo 6. Overview of State Street Bridge and State Street (Cross Street) from the roadway facing south

Prior to removal of the dam and if deemed appropriate, scour countermeasures should be installed at State Street Bridge. If dewatering of the impoundment is necessary for installation of countermeasures at State Street Bridge, it may be possible to use cofferdams to isolate and divide flows between the bridge and spillway to work in the “damp” (in standing water). Alternatively, a cofferdam installed upstream of the bridge could potentially create a surcharged upstream condition so that flow would be diverted through the former flume culvert.

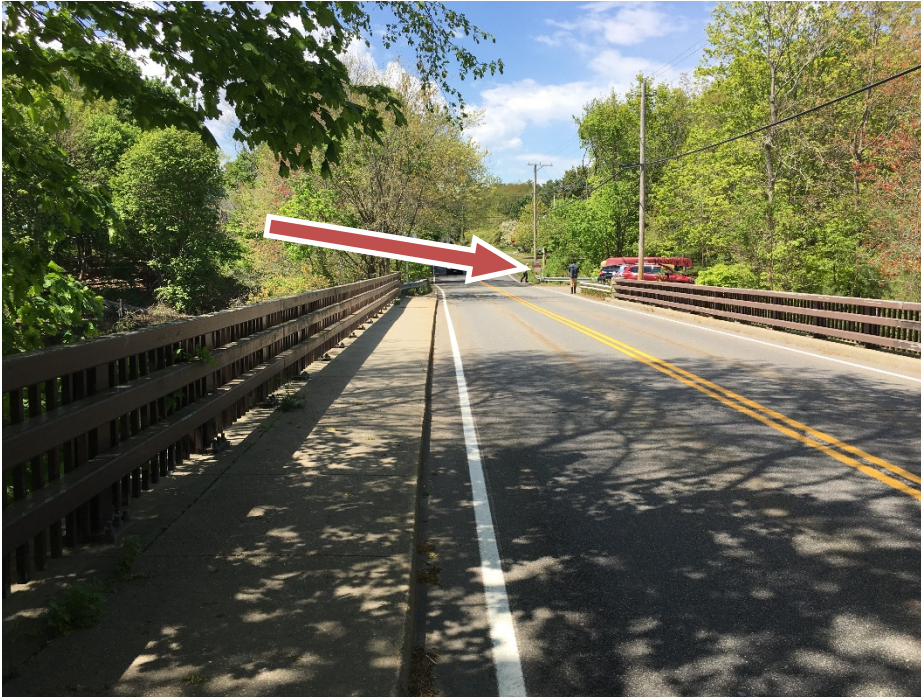
Photo 7. Overview of State Street Bridge and State Street (Cross Street) from the roadway facing north; note the location of the parking area to access dam

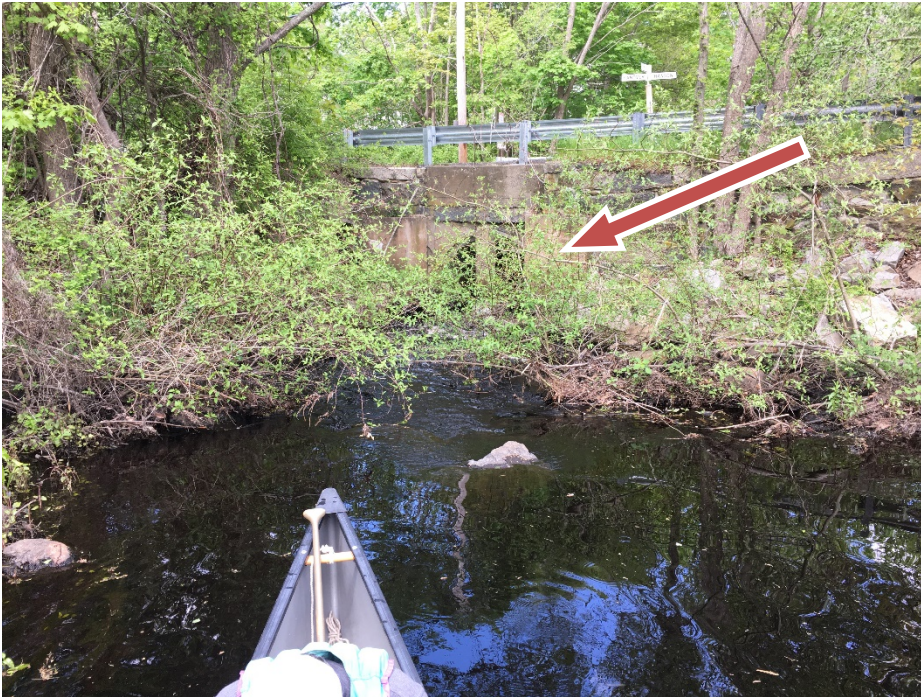
Photo 8. Overview of former flume concrete pipe inlet on the left side of the dam

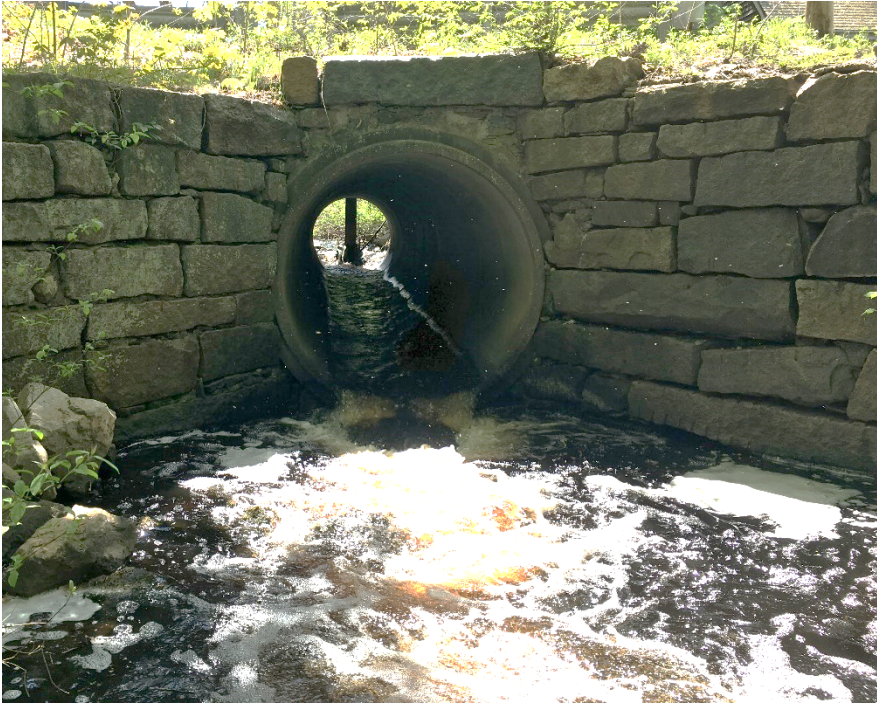
Photo 9. Overview of former flume concrete pipe outlet

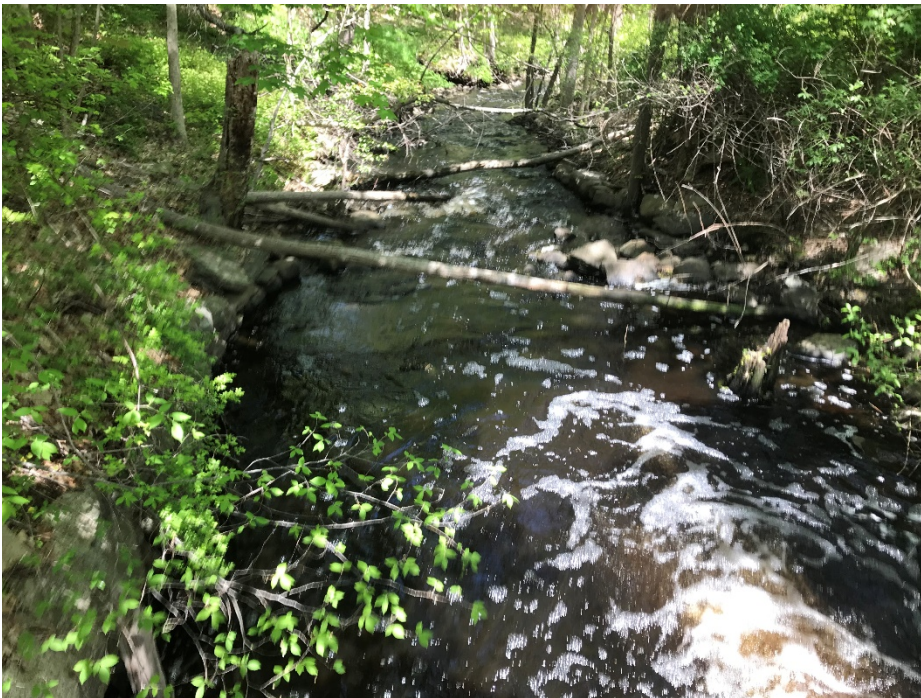
Photo 10. Overview of the old millrace facing downstream from the former flume concrete pipe outlet

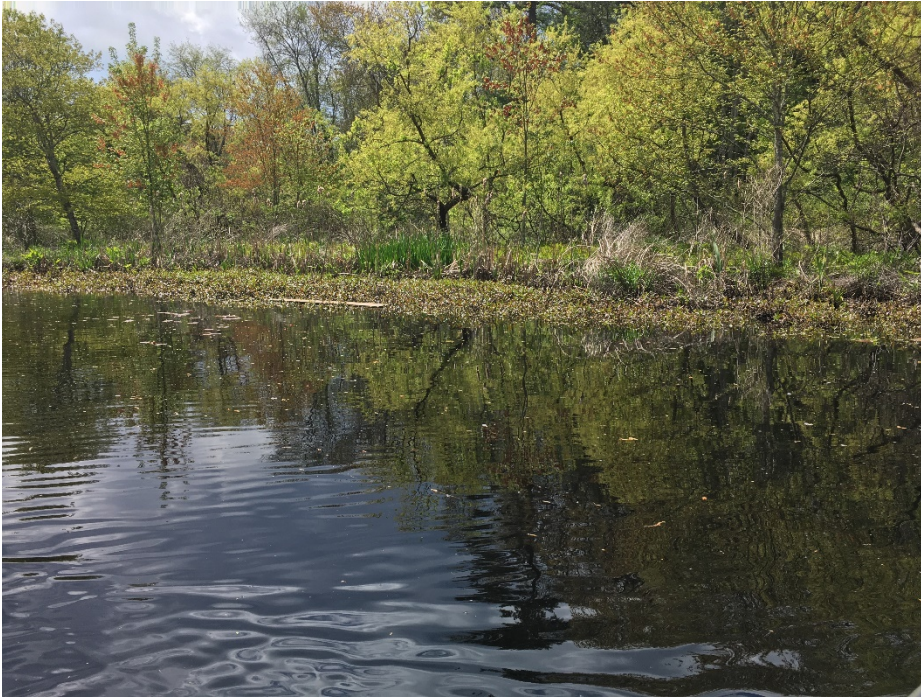
Photo 11. Overview of bordered vegetated wetlands along the upstream Indian Head River channel (typical)

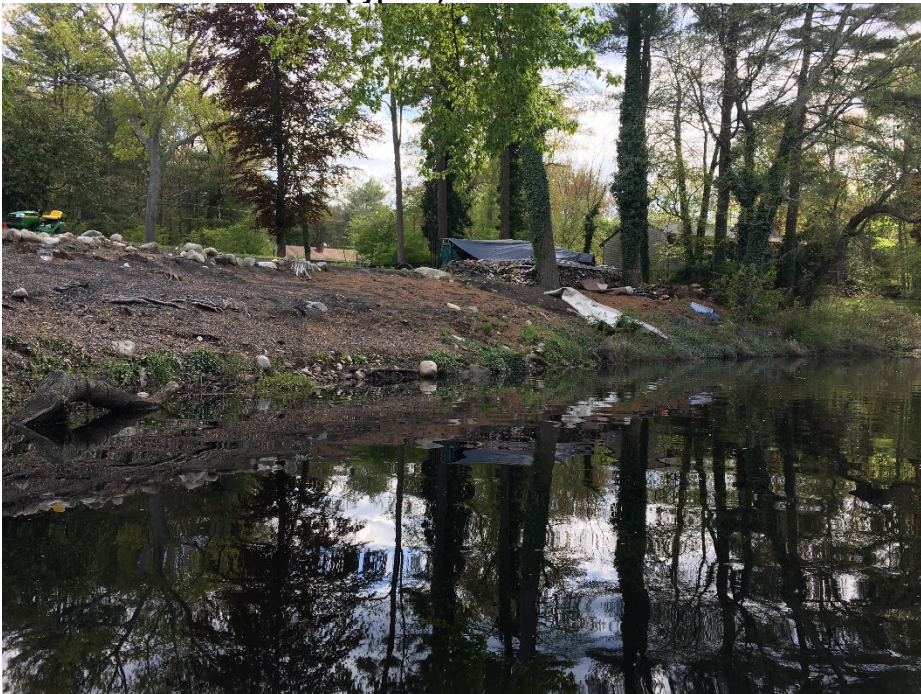
Photo 12. Overview of the right bank along the upstream Indian Head River channel
