**Site Reconnaissance and
Conceptual Design for Dam
Removal – Indian Head Dam**

Hanover and Hanson, Massachusetts

June 30, 2021

Revised March 29, 2022

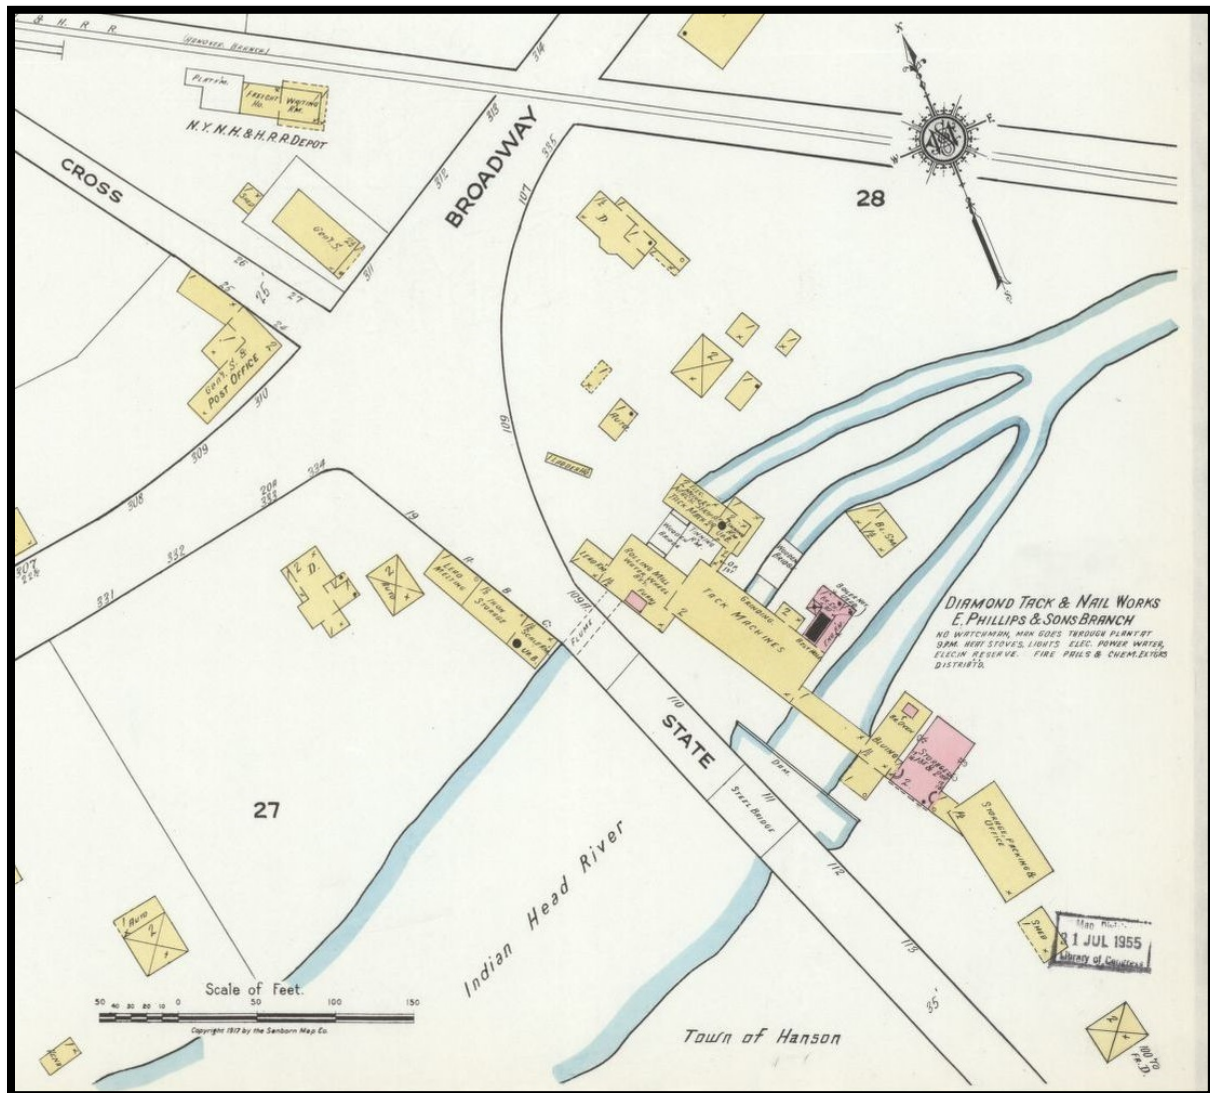
Figure 2. Zoomed in image from the Sanborn Fire Insurance Map November 1917 Hanover Massachusetts panel of South Hanover.

The November 1917 Sanborn Fire insurance Map of the village of South Hanover area of Hanover was reviewed as part of the Project (see Figure 2). The map illustrates the location and extent of the old Diamond Tack and Nail Works E. Phillips & Sons Branch factory infrastructure at Indian Head Dam. Building locations are outlined as well as locations of bluing facilities, lead melting areas, and iron storage. A railroad track appears to be located approximately 300 ft north of the factory building. The location of the flume is shown on these maps. In addition, an additional tailrace is shown between the main channel of the Indian Head River and the flume tailrace that was observed during the site visit, which appears to have since been abandoned.

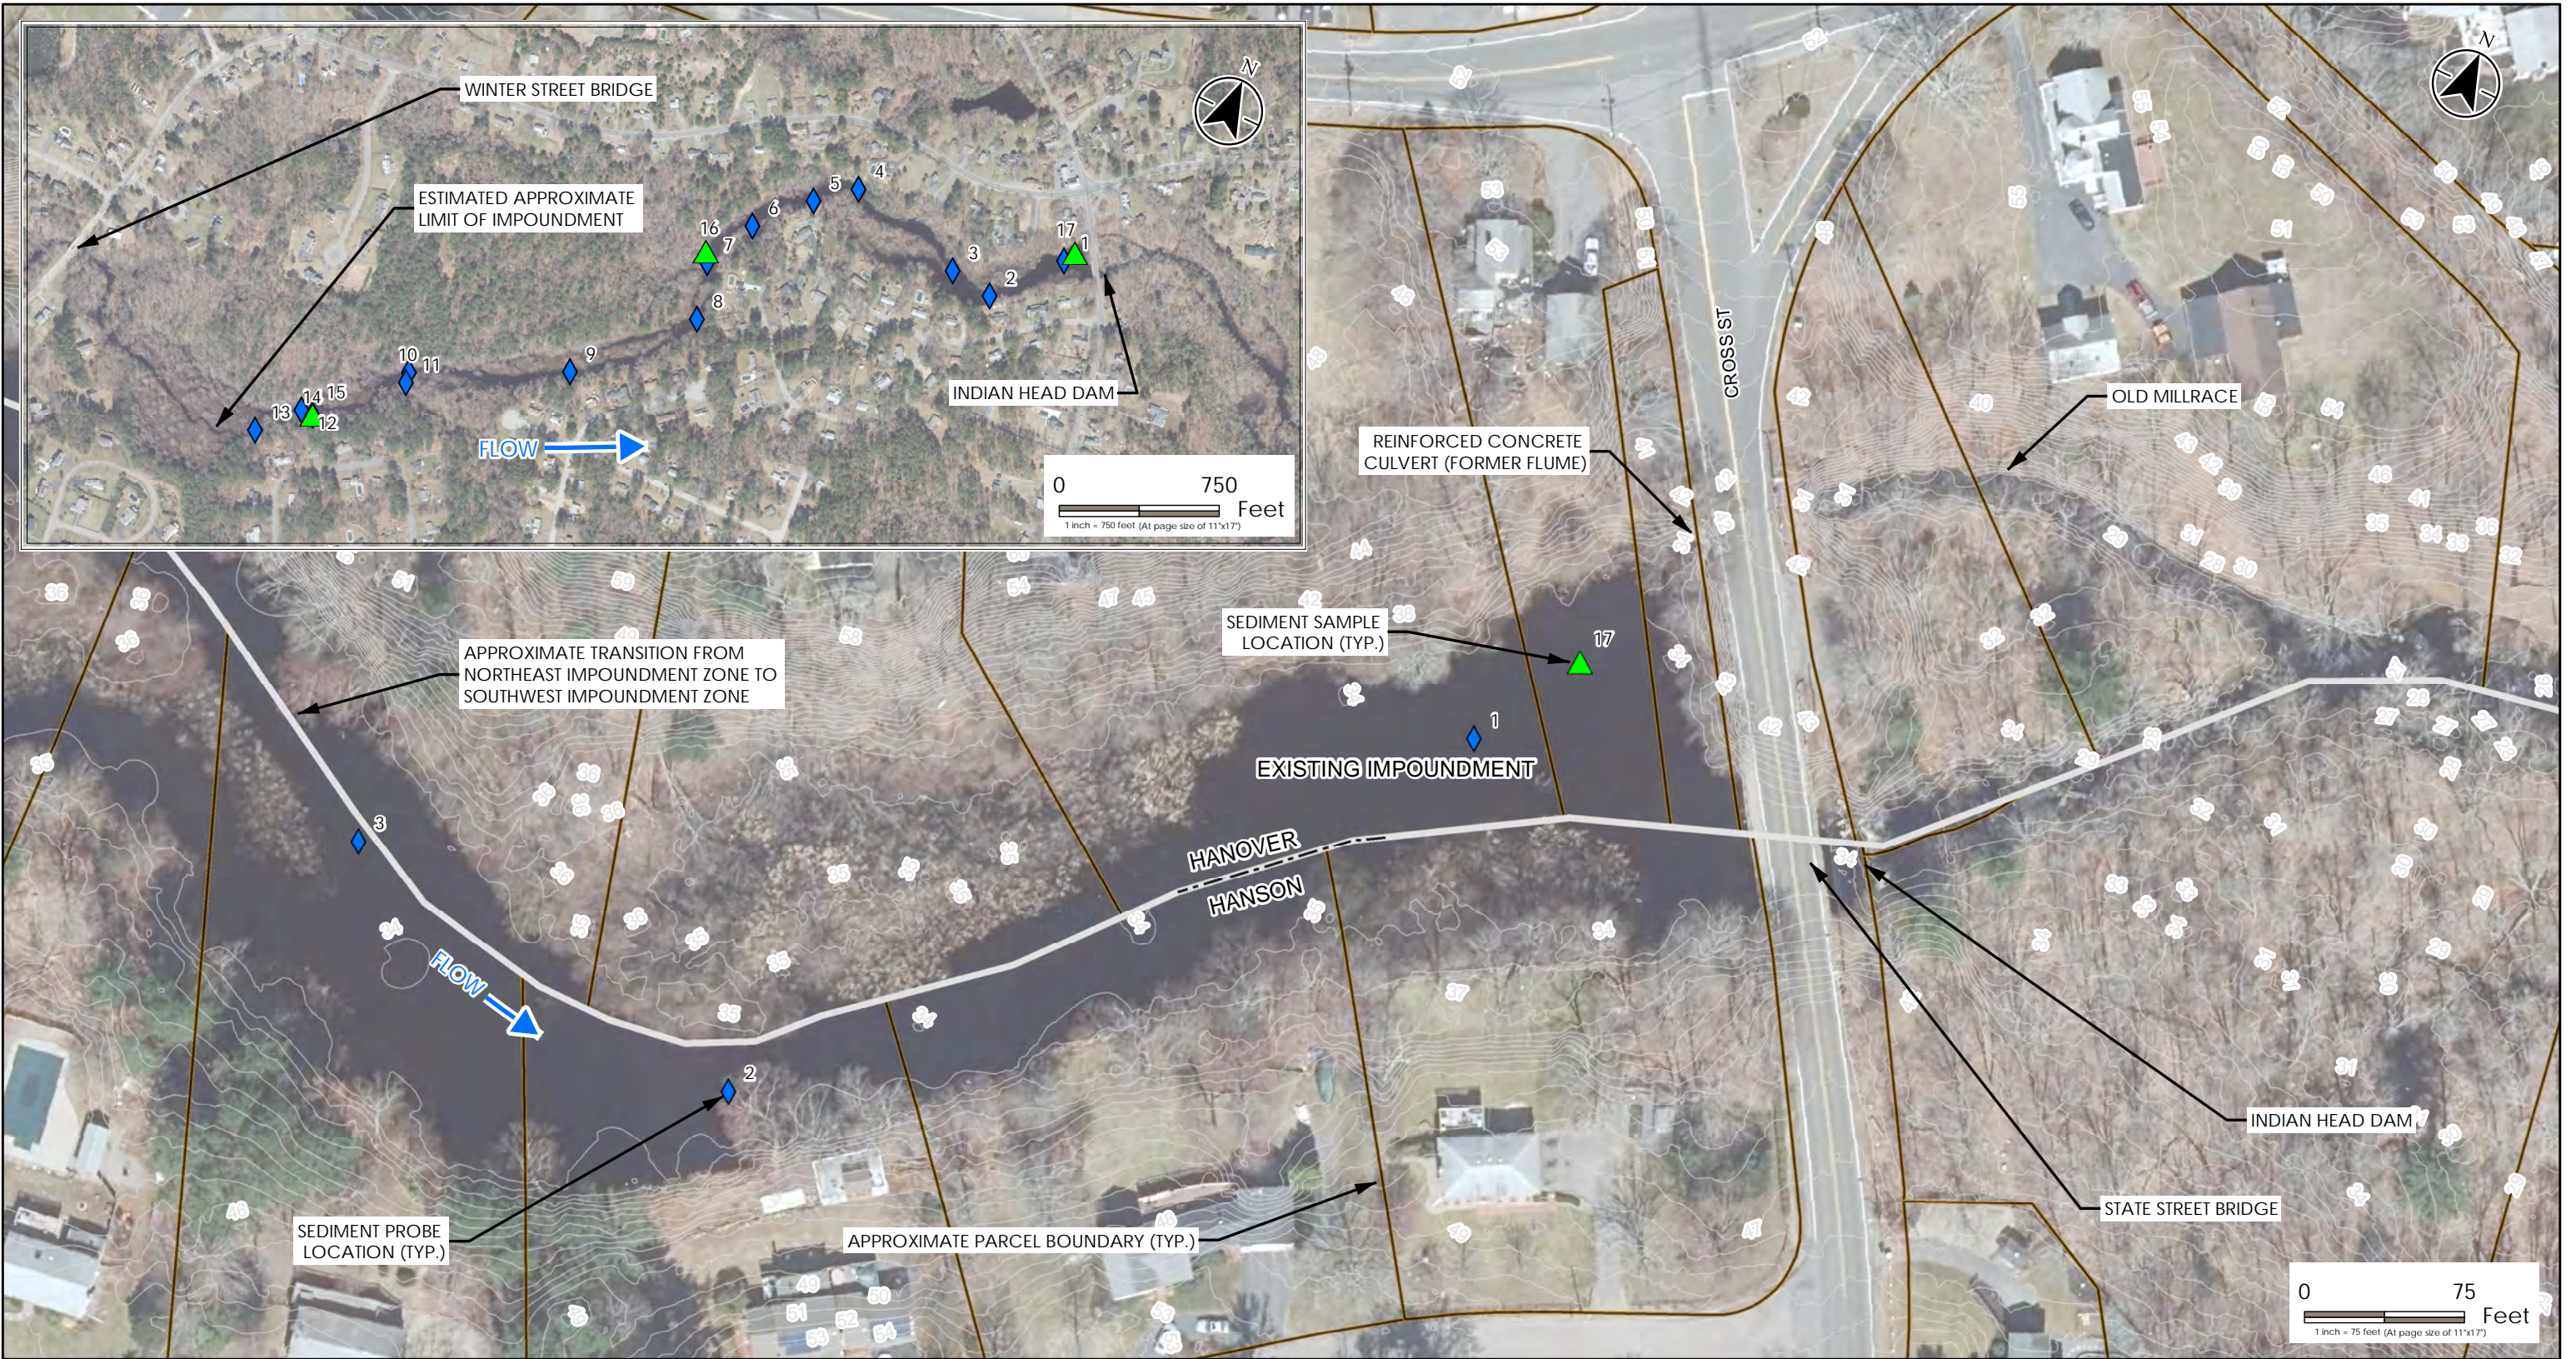
This section presents information on the Project Area obtained during the site visit and readily available information obtained by Stantec. See Figure B.1 in Appendix B for the existing conditions basemap.
