# INDIAN HEAD RIVER RESTORATION (IHRR): RECONNECTING OUR RIVERS AND ESTUARIES

# Ludden's Ford and State Street/Cross Street Dam Removals Restoration Feasibility Project

December 5, 2023

Sondra Shah, Inter-Fluve  
Neal Price, Horsley-Witten

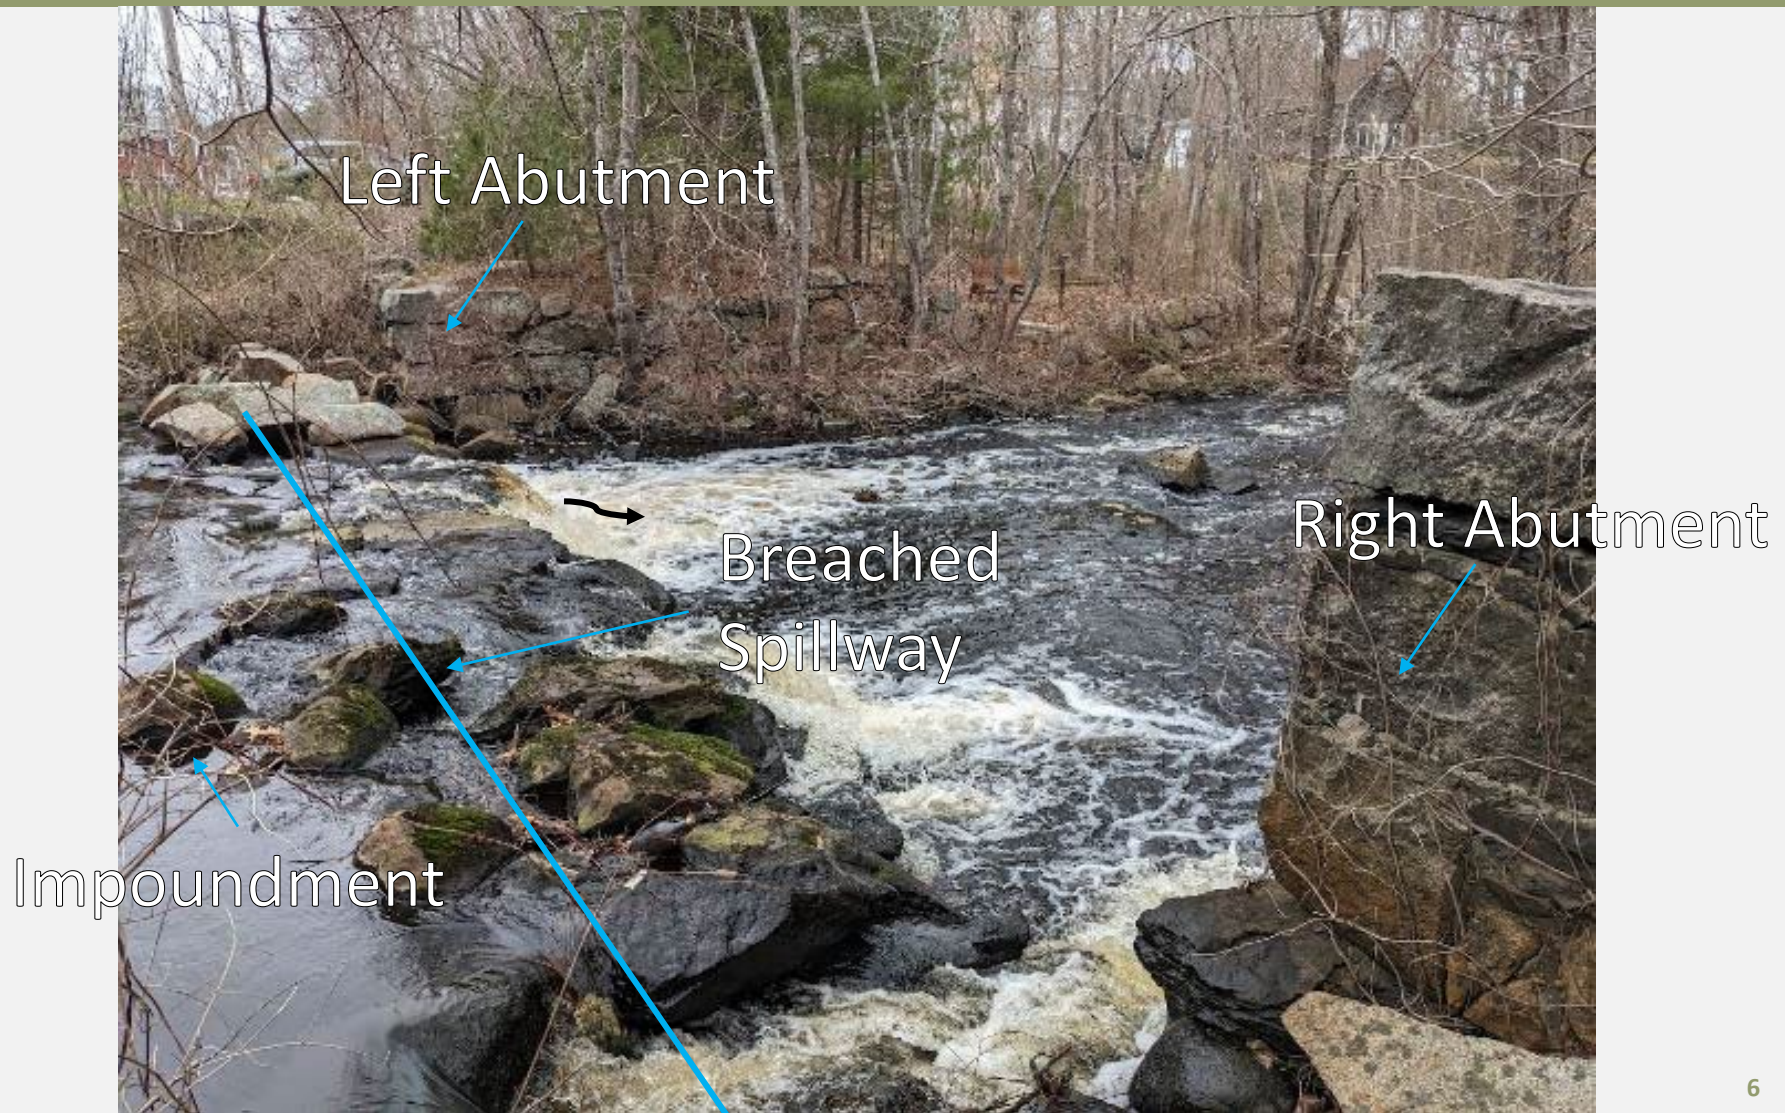
# Existing Conditions at State St/Cross St

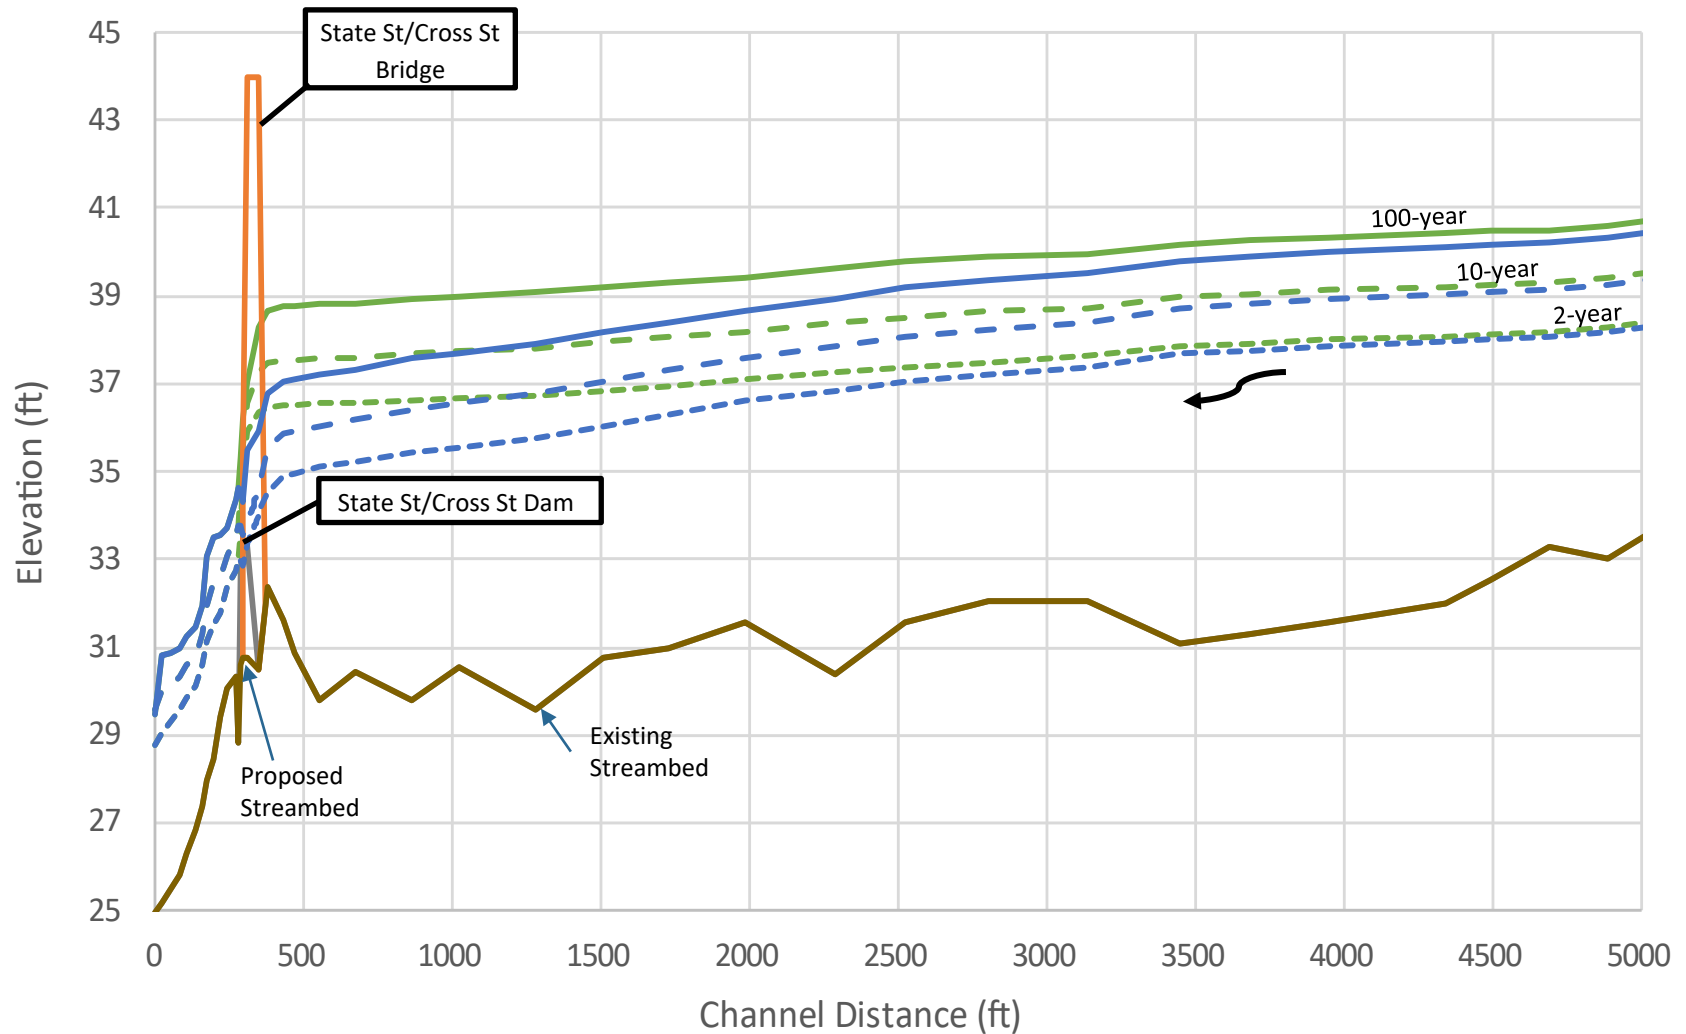
# State St/Cross St: Existing (green) vs Proposed (blue) Water Surface Profiles

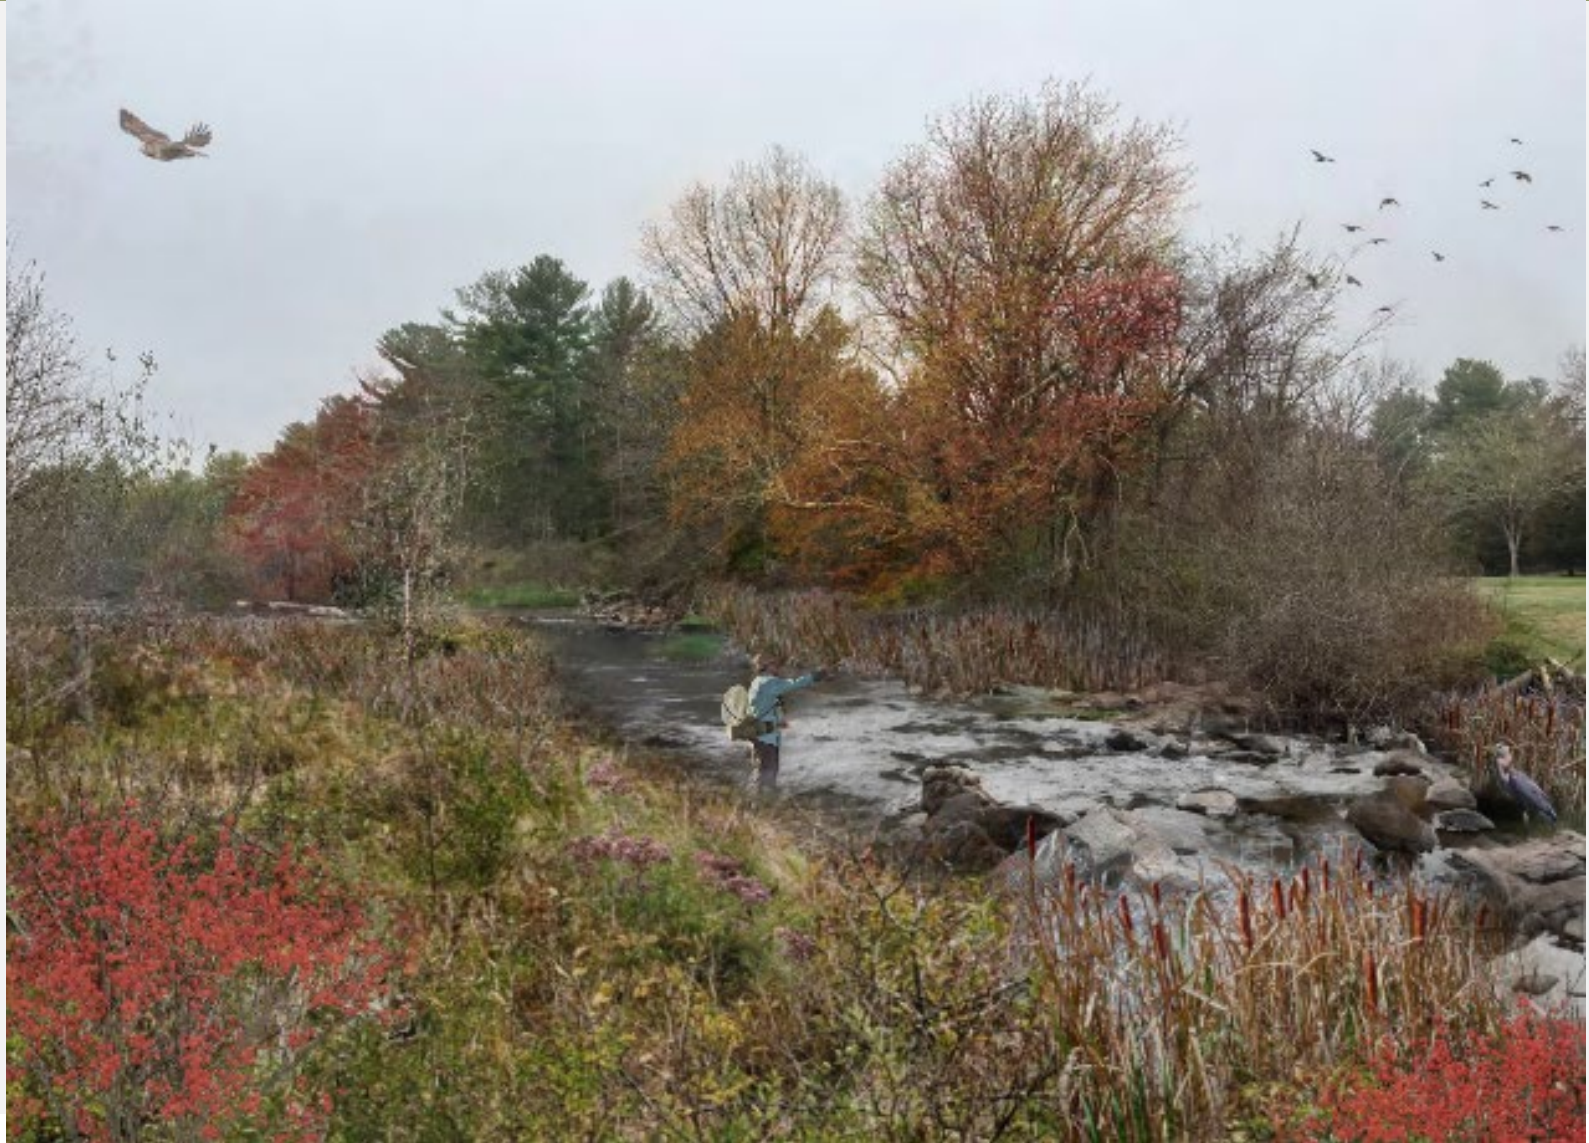
# Ludden's Ford Dam Removal and Restoration

- Protect sensitive areas.
- Remove dam spillway, right abutment, and detach left abutment from foundation remnants.
- Excavate sediment to construct channel.
- Establish a riffle at site of the dam.
- Install large wood in outer banks of meander bends to provide for additional fish habitat.
- Stabilize banks with fabric covered slope and plantings.

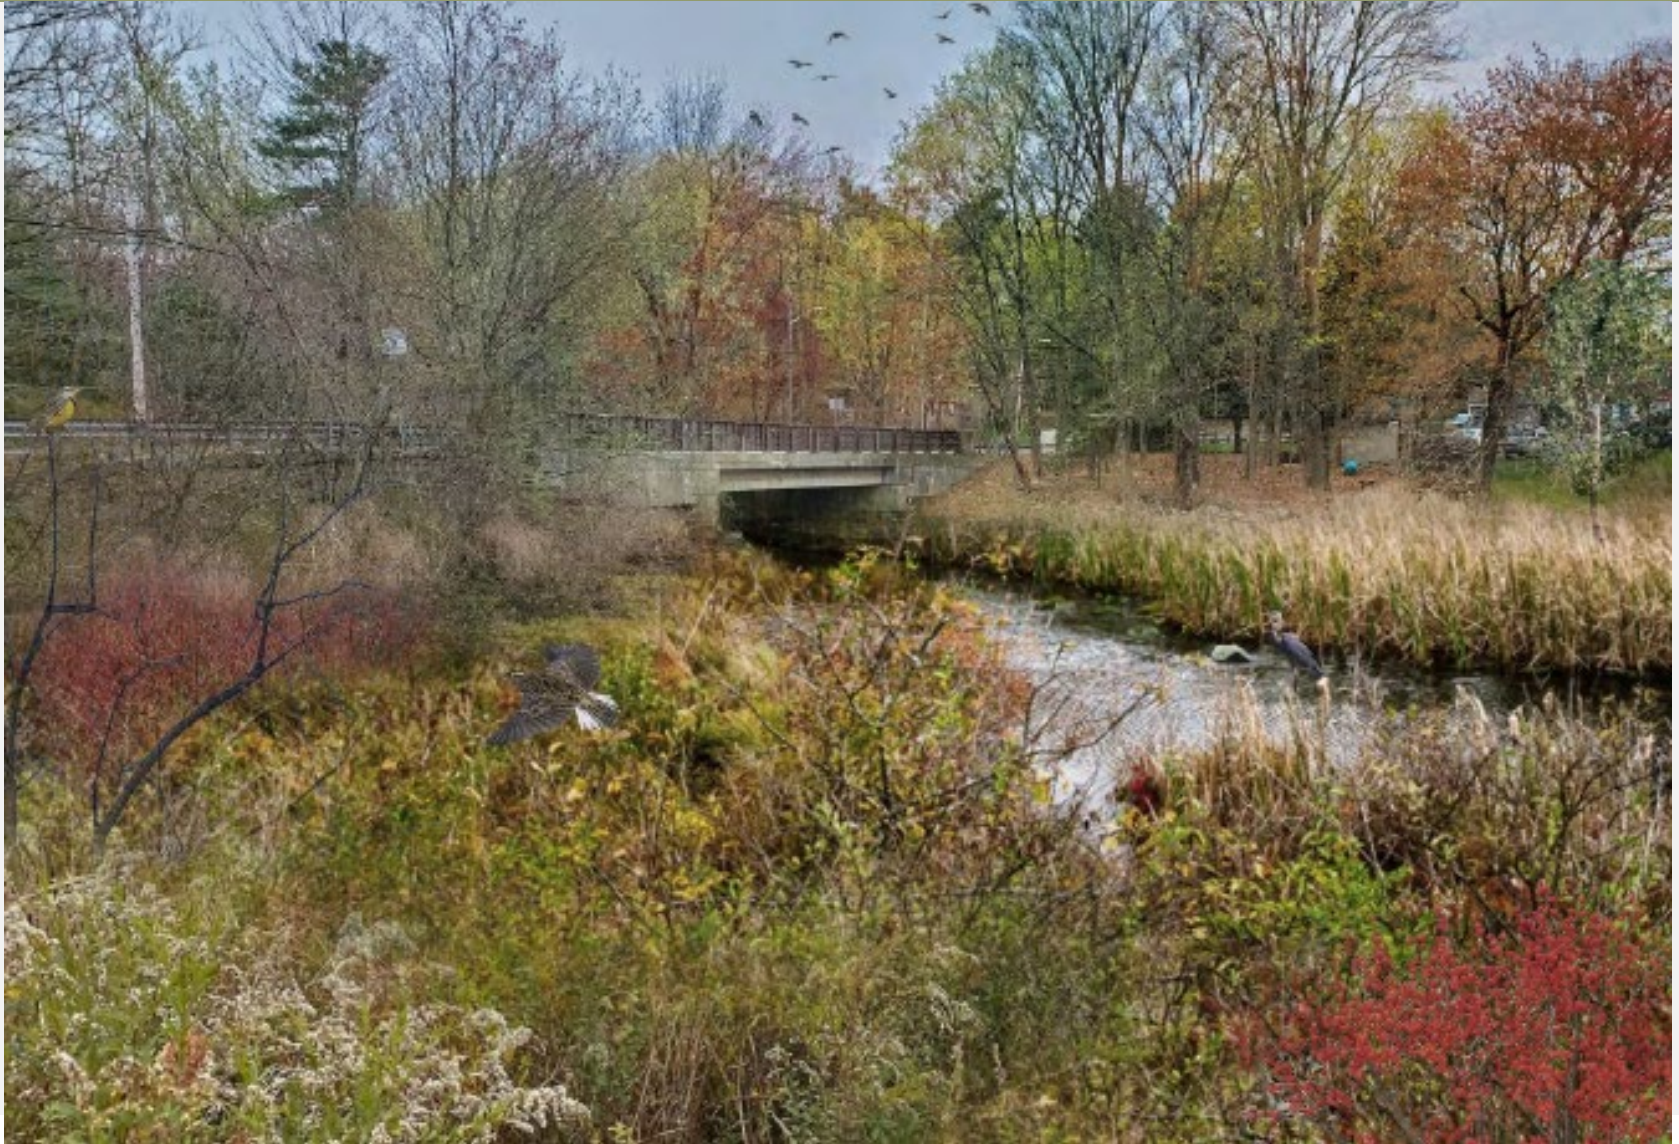
# State St/ Cross St Dam Removal and Restoration

- Protect sensitive areas.
- Remove vertical extent of dam spillway, right abutment, and left abutment.
- Remove selected stones to grade channel that provides fish passage.
- Addition of scour protection measures at the bridge.
- Stabilize banks with fabric covered slope and plantings.

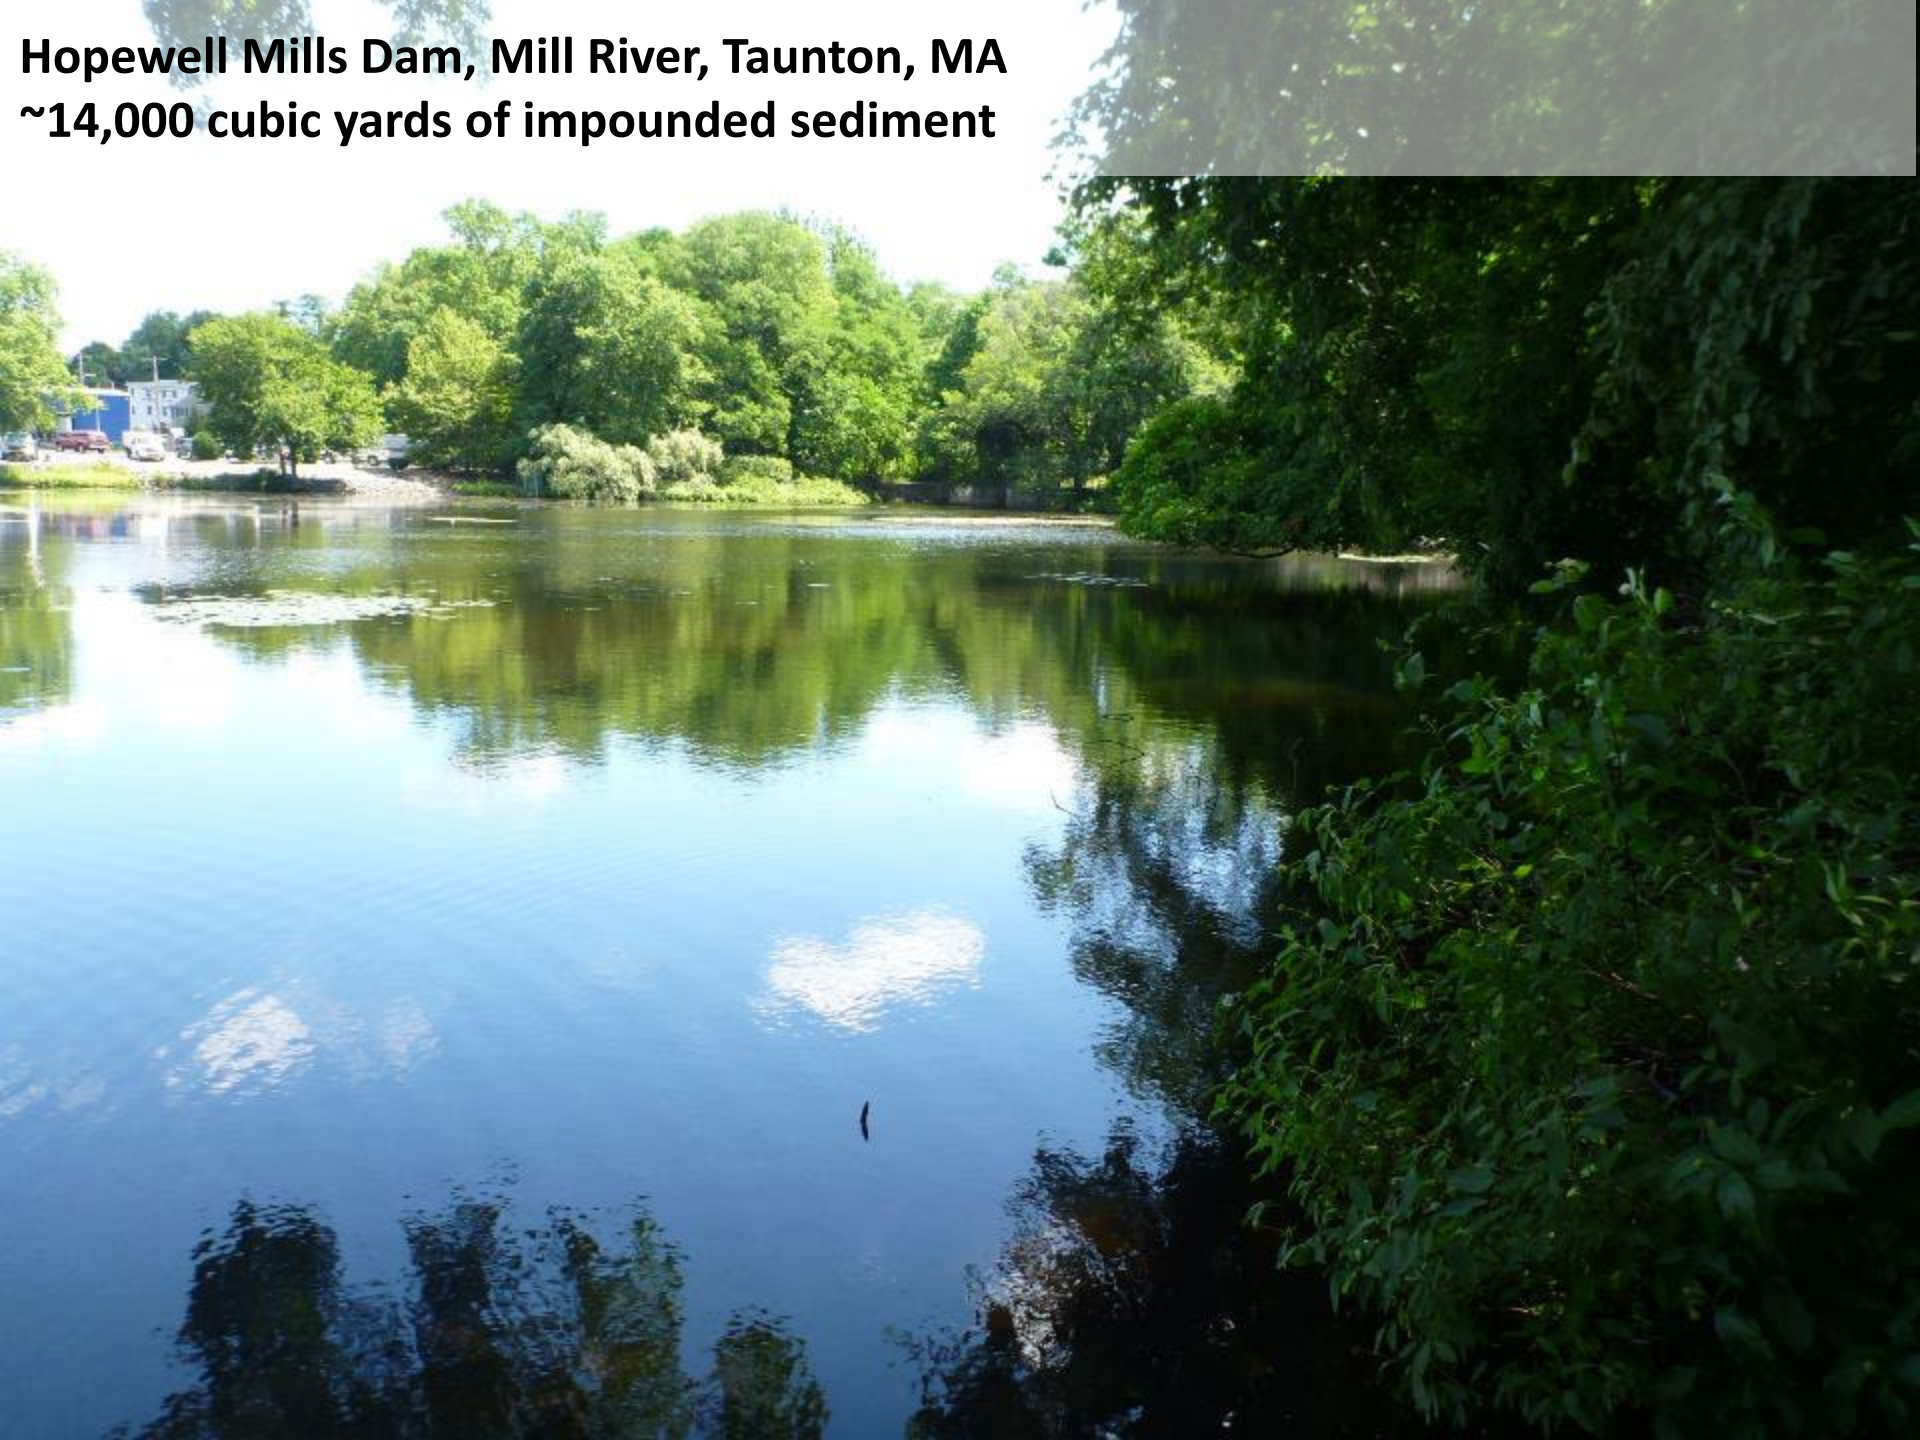
**Hopewell Mills Dam, Mill River, Taunton, MA**  
**~14,000 cubic yards of impounded sediment**

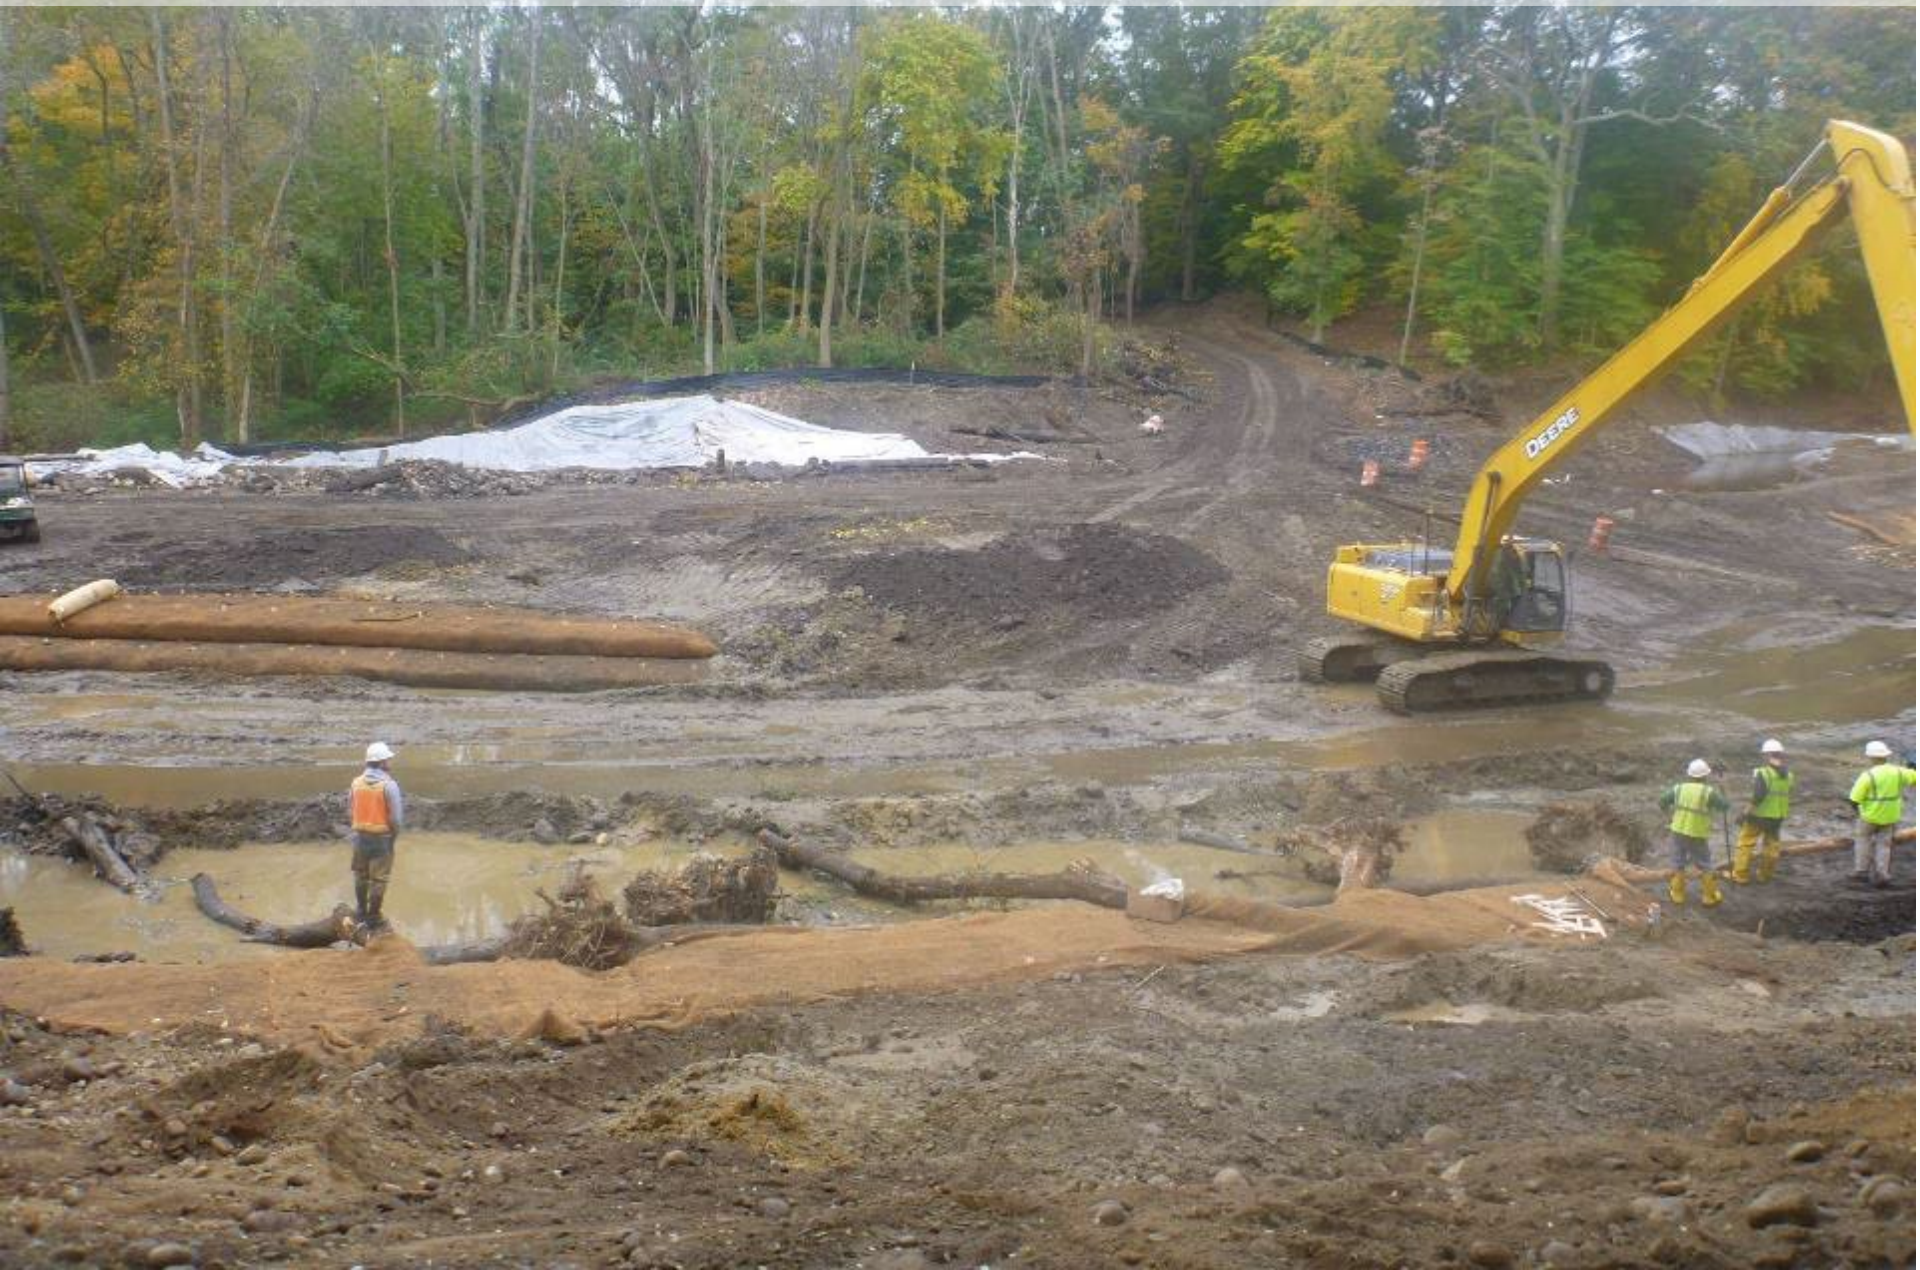
# **Hopewell Mills Dam, Mill River, Taunton, MA – During Construction**

## **Active sediment removal and channel construction**

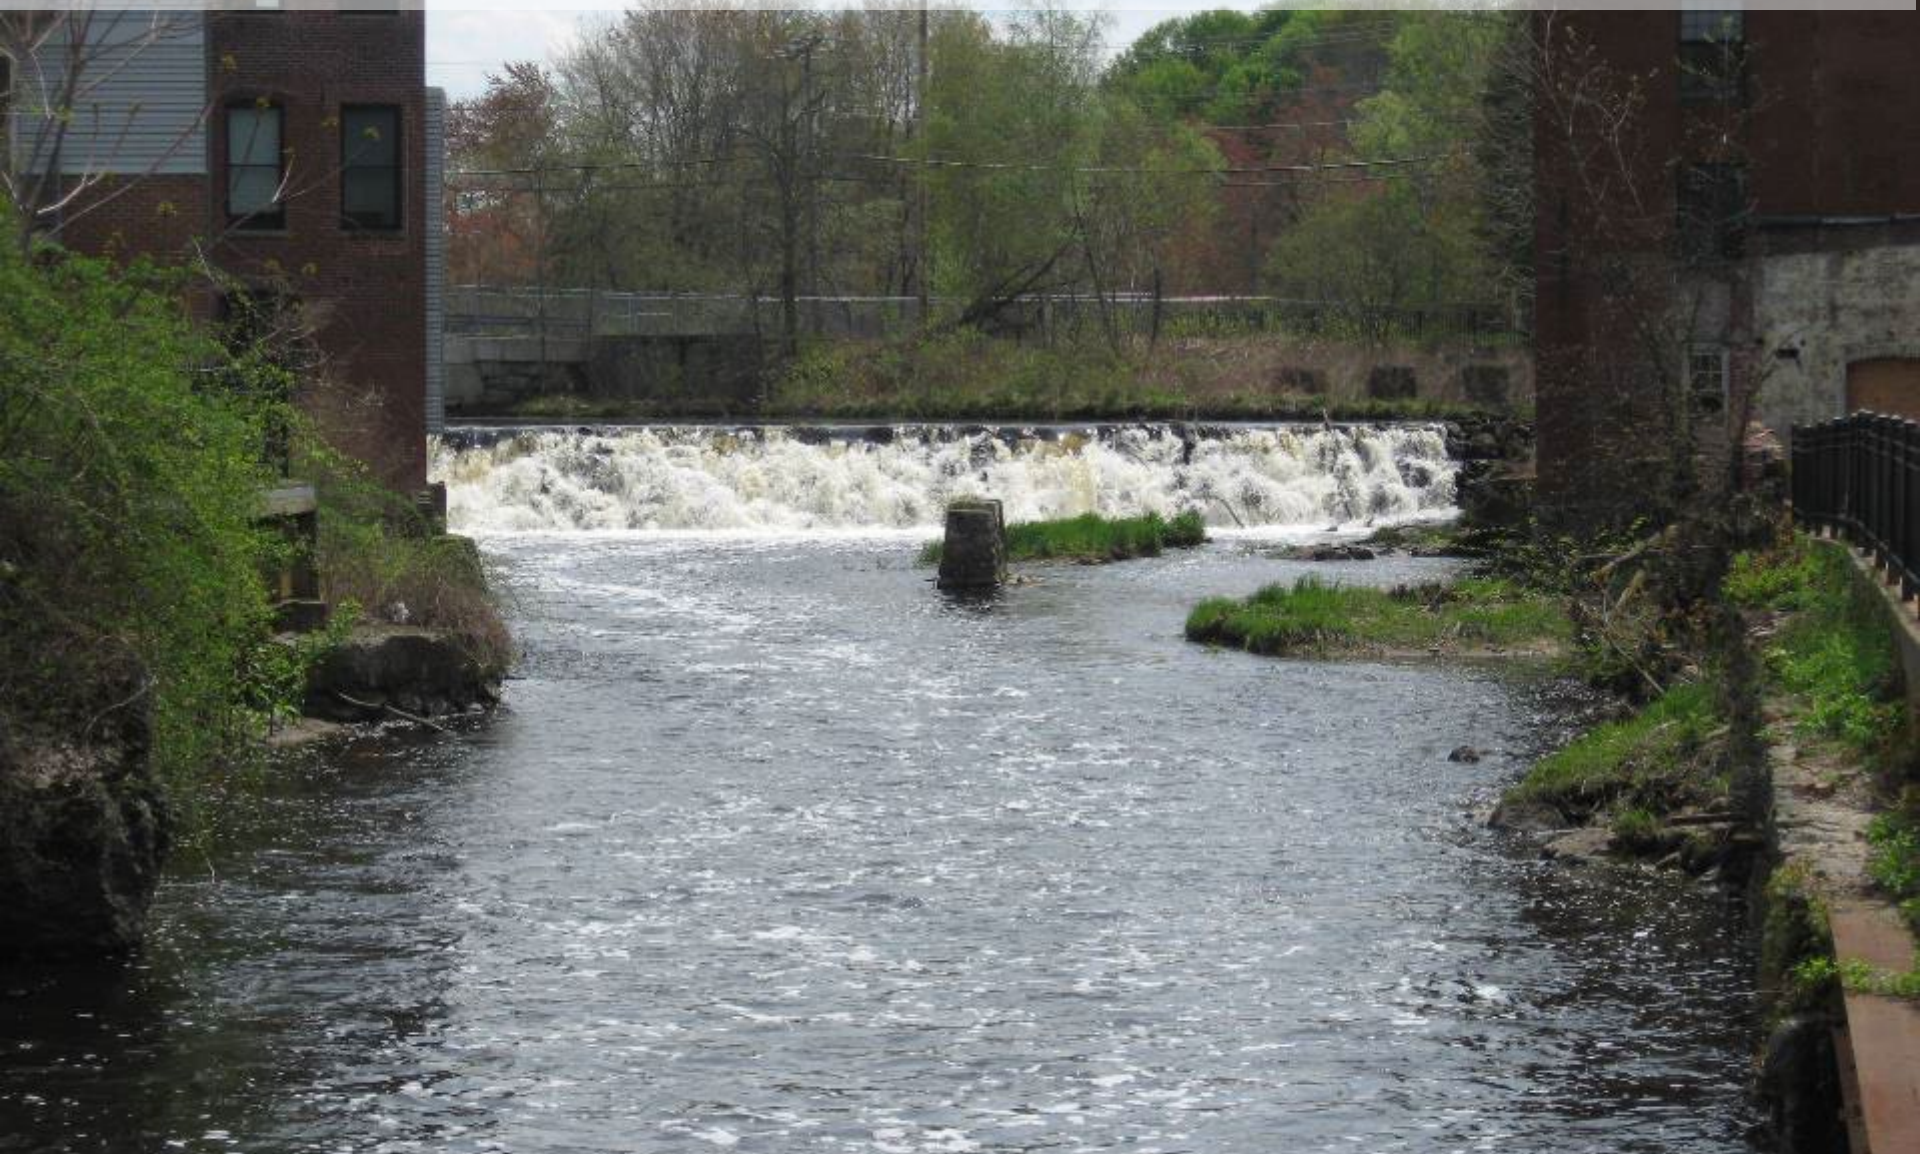
**Marland Place Dam, Shawsheen River, Andover, MA  
Looking Upstream (Dam removed in 2017)**

**Lead exceeded human health thresholds and was higher than what was found in the Ludden's Ford and State Street/Cross Street impoundments.**

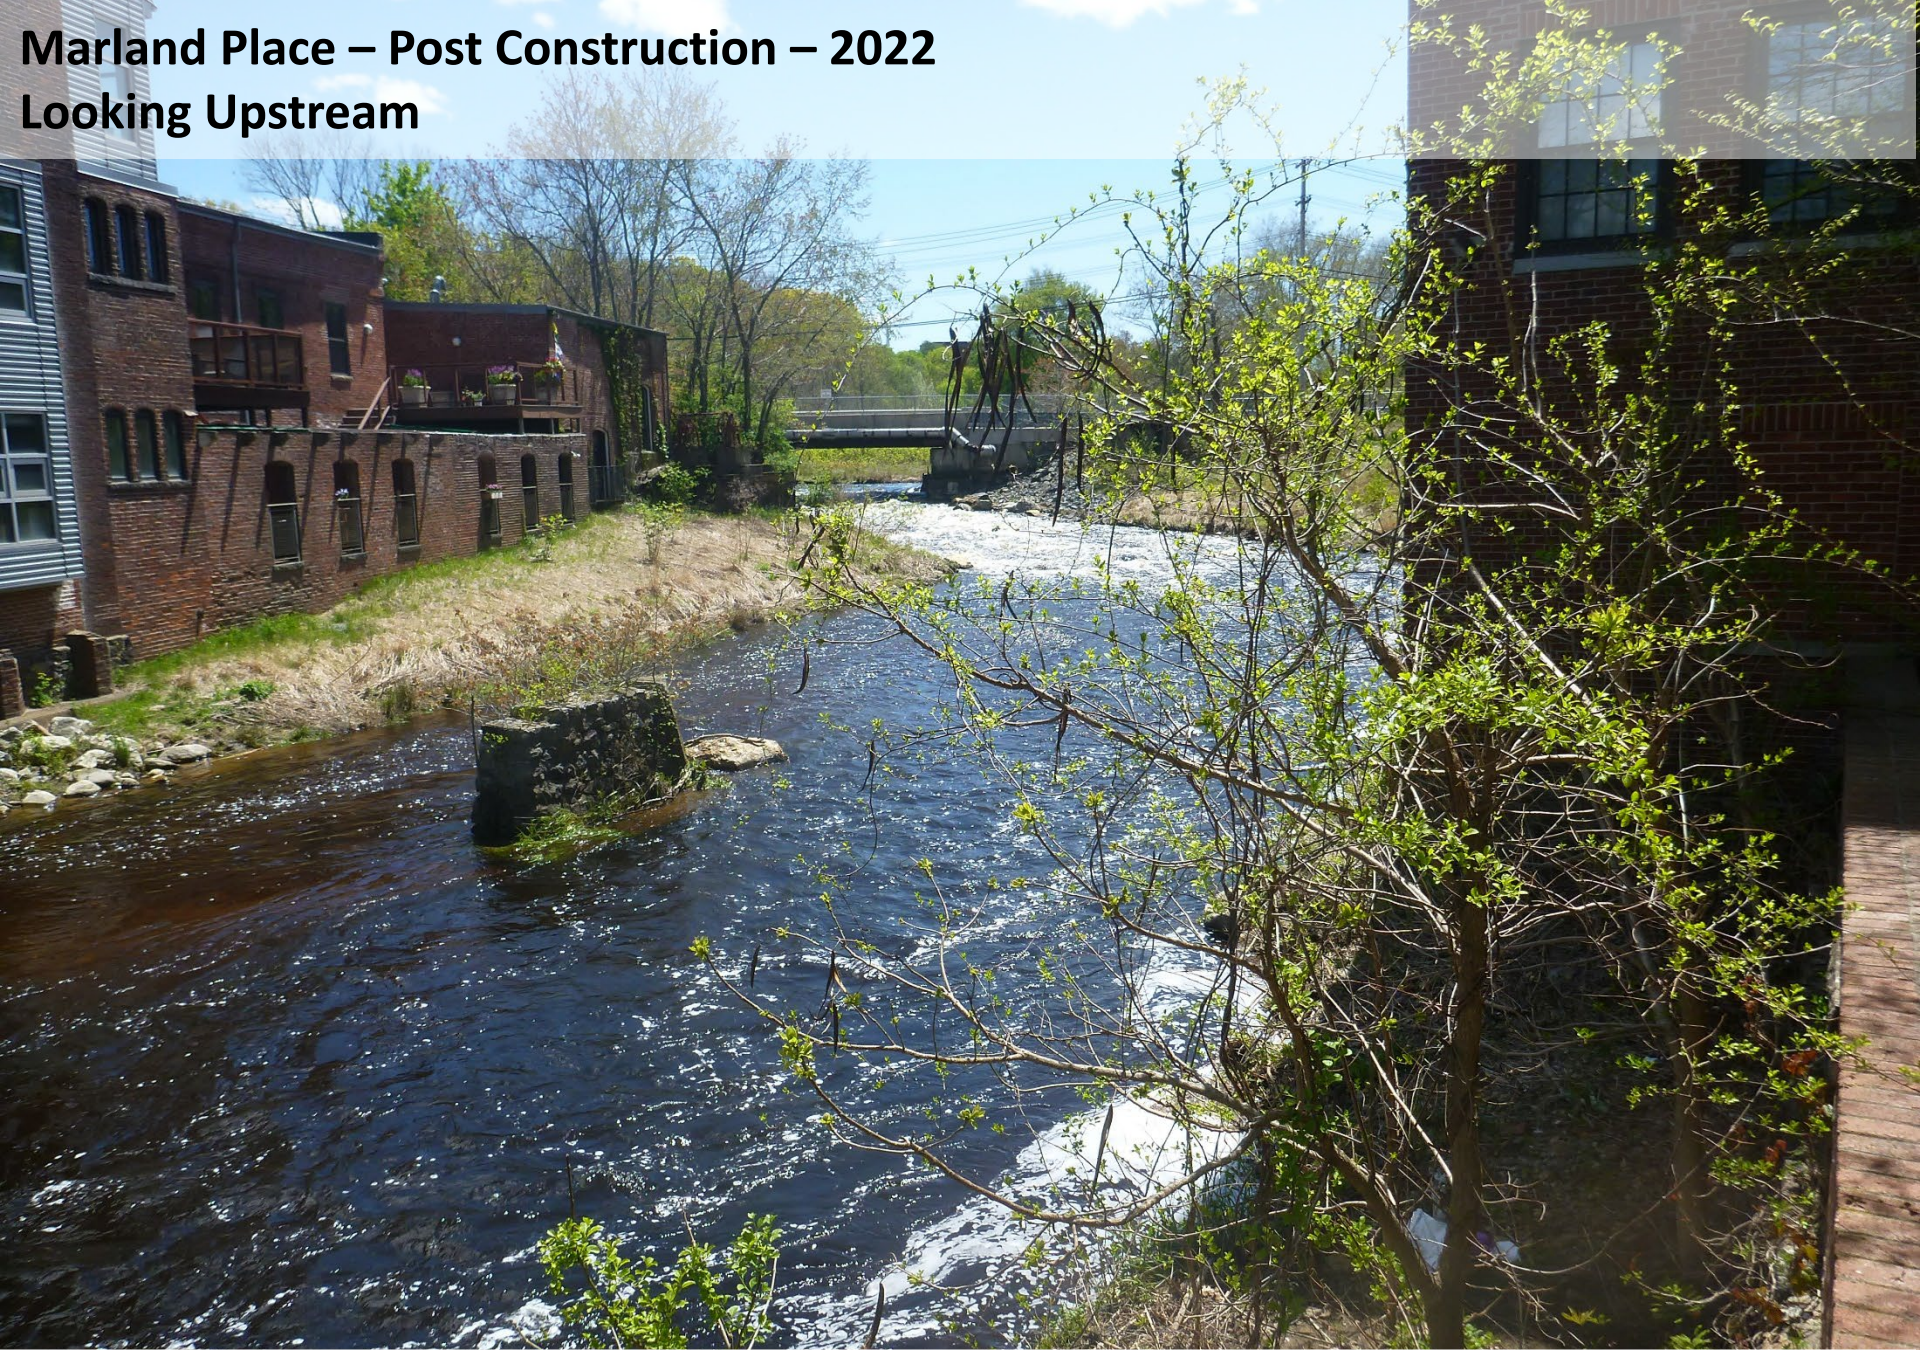
# **Marland Place – Post Construction – 2022**

## **Looking Upstream**

**Around 3,000 cu. yds of sediment removed to an offsite landfill**

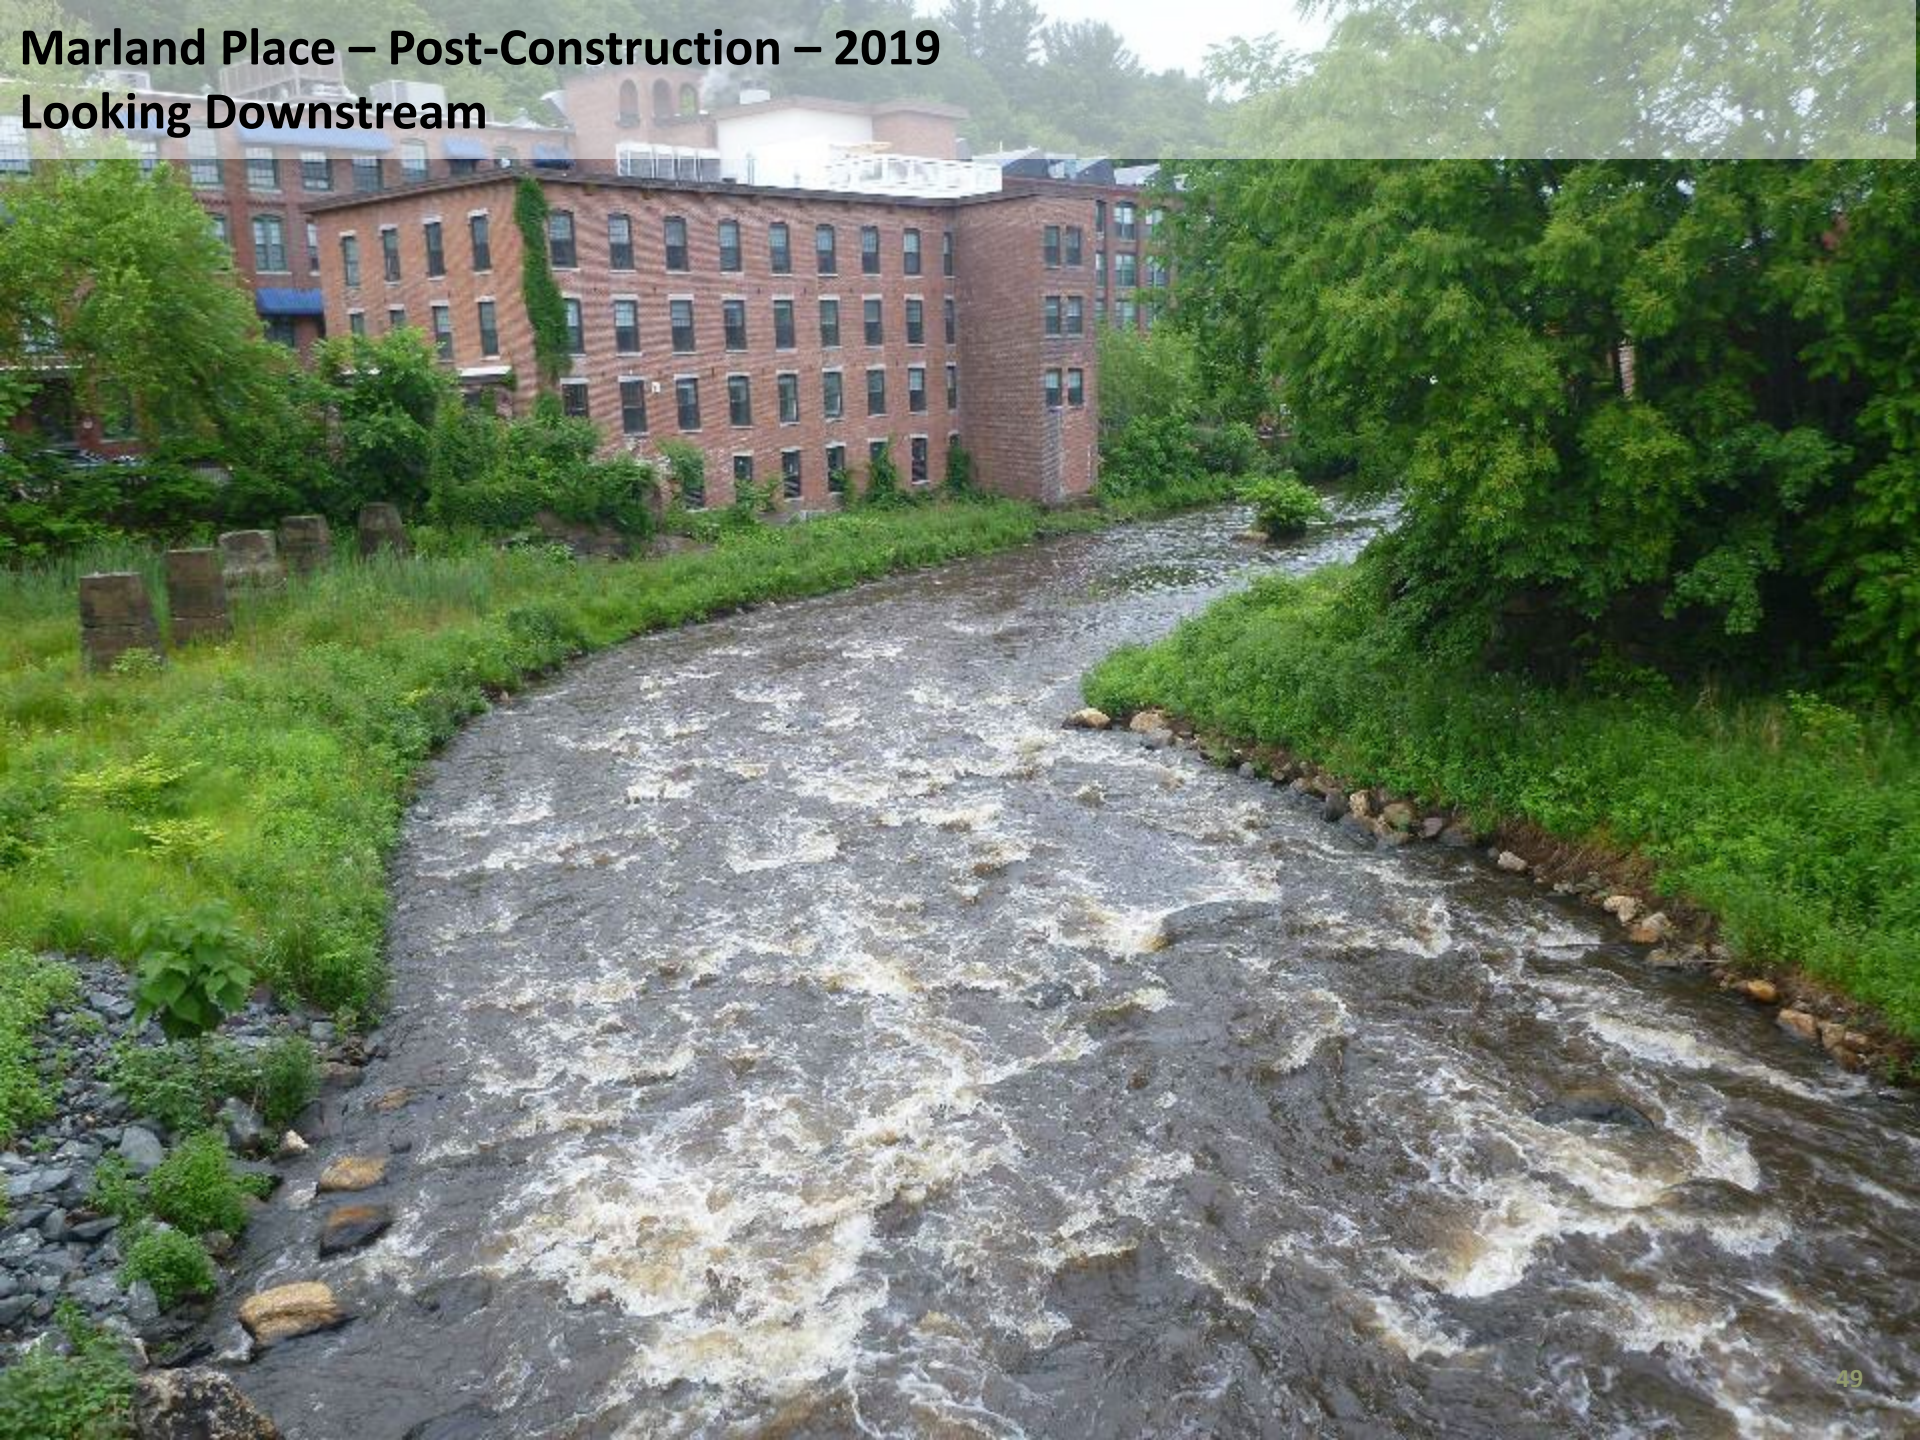
# Marland Place – Post-Construction – 2019

## Looking Downstream
